Commercial Venting CASE STUDY

Impossible Made Possible With Integral Chased Grease Duct

Factory-Built Grease Duct - 5 Years Later...

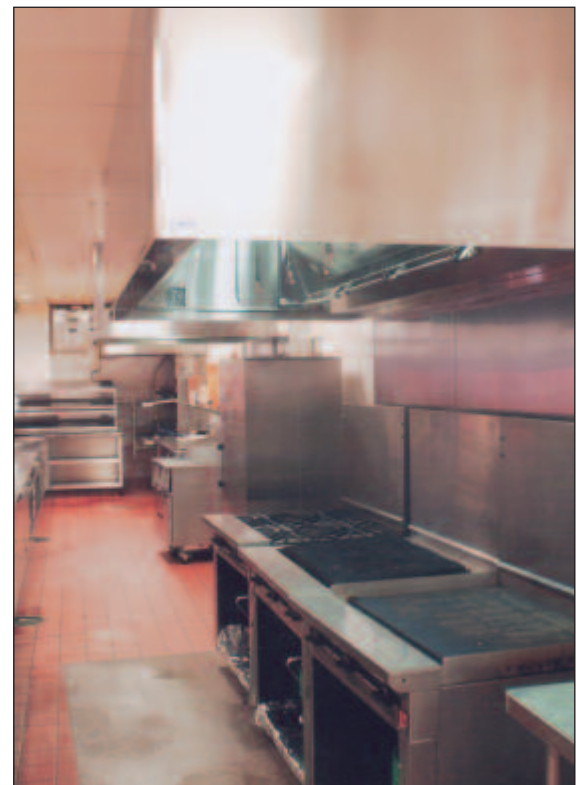
Fifteen new hoods were installed.

New kitchen area plans departmentalized the food preparation and cooking stations on both the main and lower levels. In all, 15 new hoods were installed. The new system handles over 56,000 cfm of kitchen exhaust air. Each hood is equipped with its own blower.

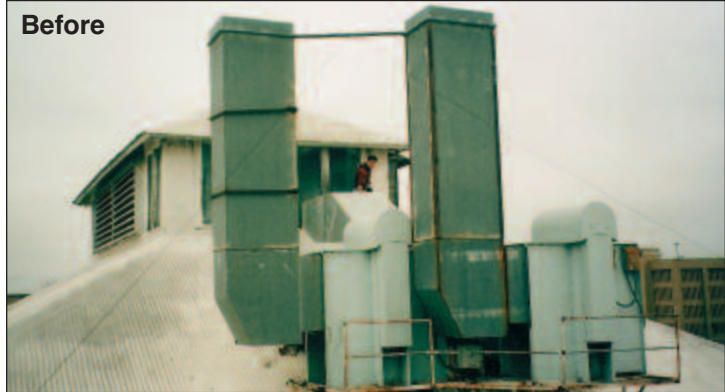
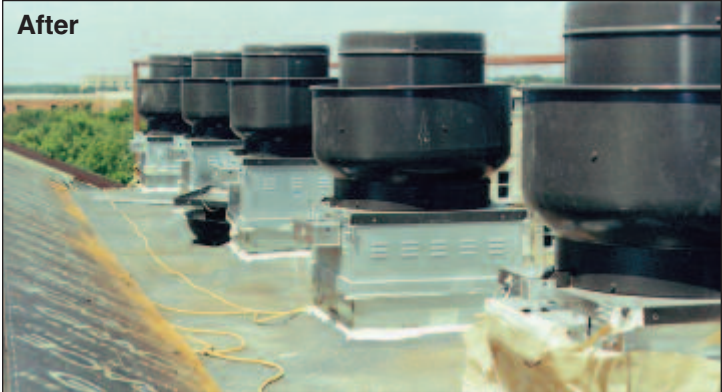
Three large exhaust fans were replaced with multiple smaller fans to serve several smaller cooking and serving stations. This allowed more efficient use, but required multiple duct installations and penetration through already congested areas.

The previous kitchen layout incorporated three large exhaust fans, two fans exhausted four extremely large hoods in the kitchen. The third fan served several smaller hoods in the serving area. These powerful fans were set at the top of the building and, during operation, it was necessary to open the building windows to provide make-up air.

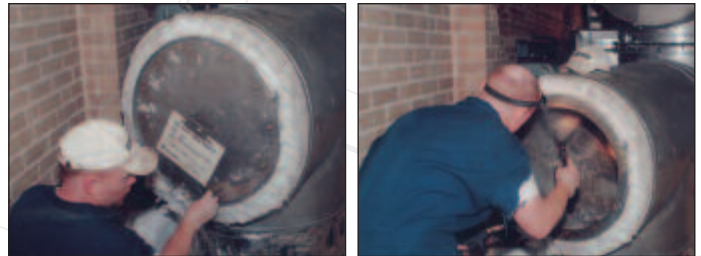
Toolless access panels speed cleaning time. Cleaning process requires no brushing or scraping.

The removal and replacement of the liquid tight toolless access panels on the Metal-Fab 4G duct is fast and easy. Triple B foreman Justin Sullivan commented, "The covers with the wing nuts make it real easy."

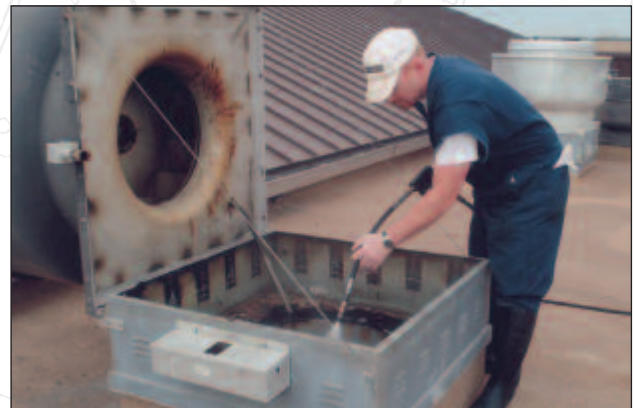
Spraying from roof down, no leaks below.
