# Commercial Venting CASE STUDY

## Impossible Made Possible With Integral Chased Grease Duct

# Factory-Built Grease Duct - 5 Years Later...

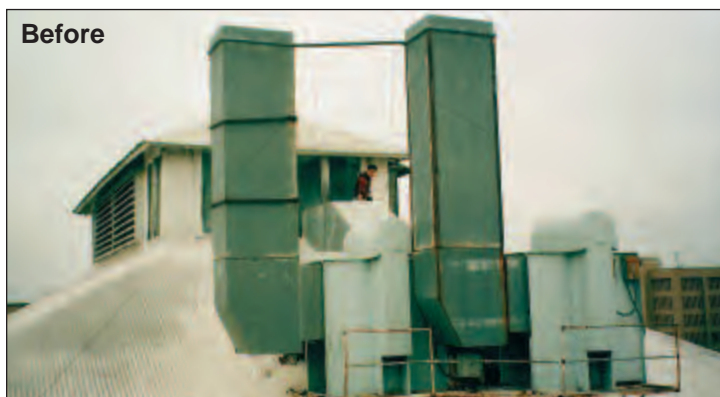
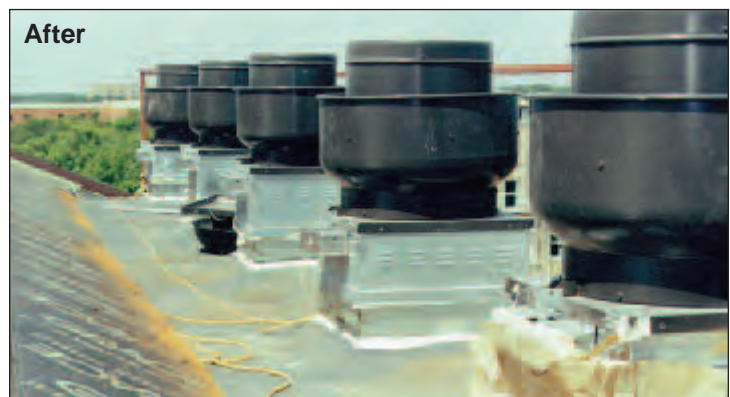
Three large exhaust fans were replaced with multiple smaller fans to serve several smaller cooking and serving stations. This allowed more efficient use, but required multiple duct installations and penetration through already congested areas.

The previous kitchen layout incorporated three large exhaust fans, two fans exhausted four extremely large hoods in the kitchen. The third fan served several smaller hoods in the serving area. These powerful fans were set at the top of the building and, during operation, it was necessary to open the building windows to provide make-up air.
